# EXHIBIT "A"

Re: Structural Review of Bridge and Abutment Walls at Wagonwheel  
Wagonwheel Bridge  
Wagonwheel Trail Bridge between La Costa Ct. and Country Club Rd.  
Pantego, Texas  
Falkofske Engineering Job No. 170.14  
Texas Registered Engineering Firm #F-4038

**Pictures from Field Review 4-17-14**

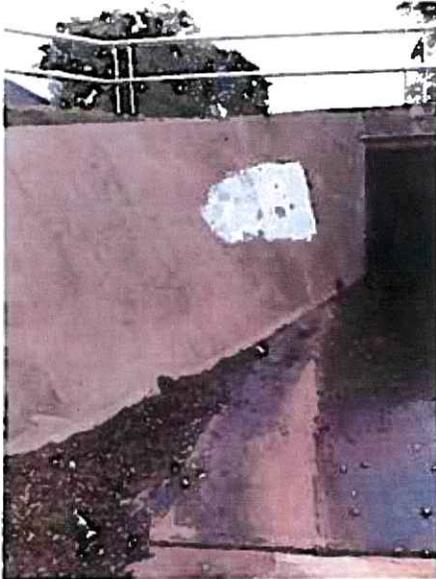
- I noted some rebar exposed and heavily rusted at the intersection of the upstream wing walls and the bridge.
- I noted a crack on the downstream wing wall on the north.

Picture 1 – A picture of the downstream wing wall on the north. Note the cosmetic crack near the bridge.

- The intersection of the stem walls and foundation slab under the bridge should be waterproofed. This should be done to protect the rebar that connects the walls to the foundation slab. While this rebar could not be seen I did not note any signs that suggested it has been compromised. At this time it should be protected for long-term performance.
- The downstream wing walls seemed to be performing as originally intended. At this time I do not see any reason to replace these walls. I did note a crack in the face of one of these walls this crack seemed cosmetic in nature and may be repaired if desired.

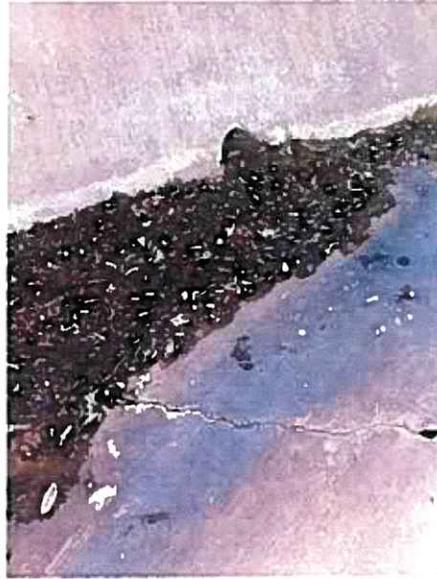
- I noted weep holes on the downstream wing walls were clogged.
- I noted weep holes on the downstream wing walls were weeping water.
- I did not note any signs of sliding of the wing walls.

Picture 3 – A picture of one of the clogged weep holes.

I recommend opening up a portion of the road just behind the bridge wall to expose the condition of the soil here. It is likely that this portion of road will have to be removed and the soil replaced in this area before re-topping the bridge. I would also recommend the upstream wing walls be removed and replaced, with special attention paid to the connection detail of the existing bridge wall and the new wing walls. The weep holes for the downstream wing walls should be cleaned.

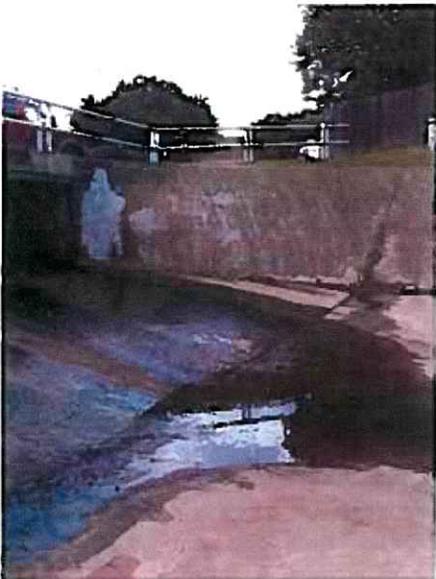
Picture 2 – A picture of the downstream wing wall on the south side.

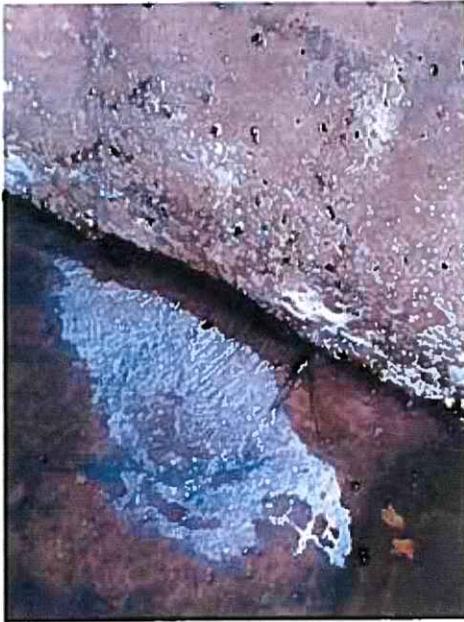
- I noted some spalling of concrete and wear at the intersection of the stem walls and the slab supporting the bridge.
- I noted some damage to the concrete at the intersection of the wing walls on the upstream side.

Picture 5 – A picture of the stem wall connection to the slab.

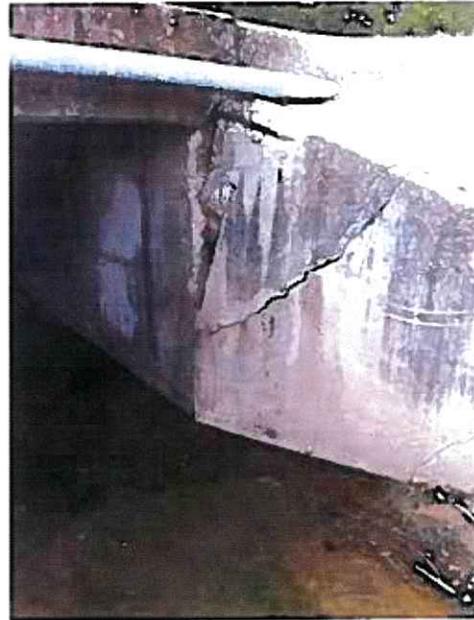
Picture 7 – Another picture of the upstream wingwall on the north side.

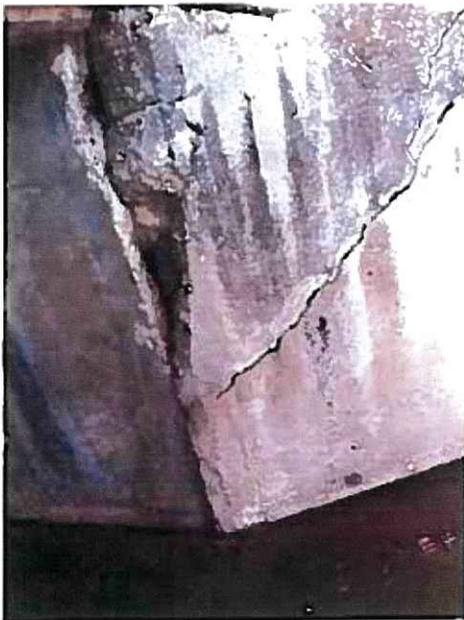
Picture 6 – A picture of the upstream wingwall on the north connection to the bridge. Note the significant spalling and damage.

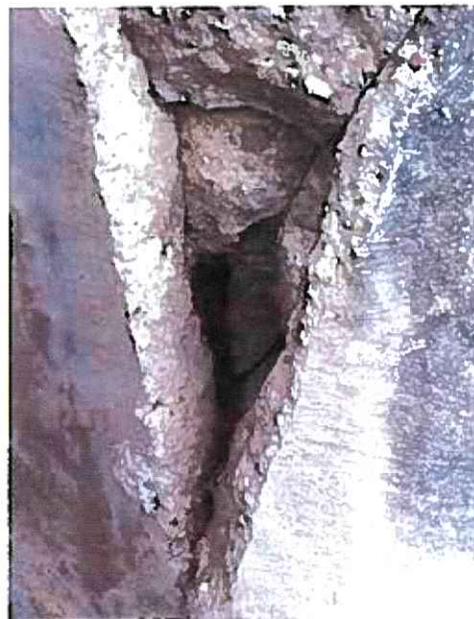
Picture 8 – Another picture of the upstream wingwall on the north side. Note the completely rusted rebar.

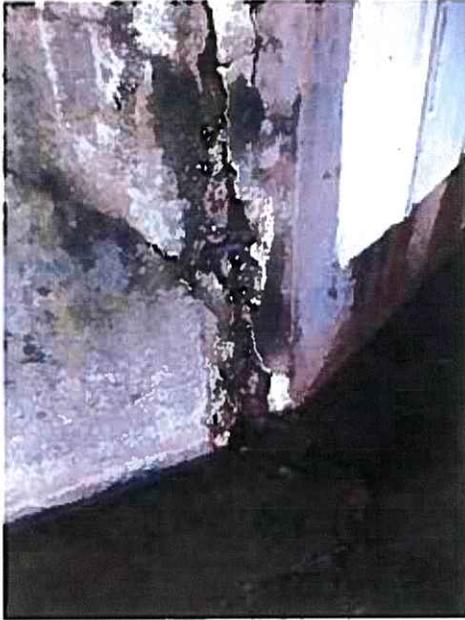
Picture 9 – A picture of the upstream wing wall on the south at the connection to the bridge.

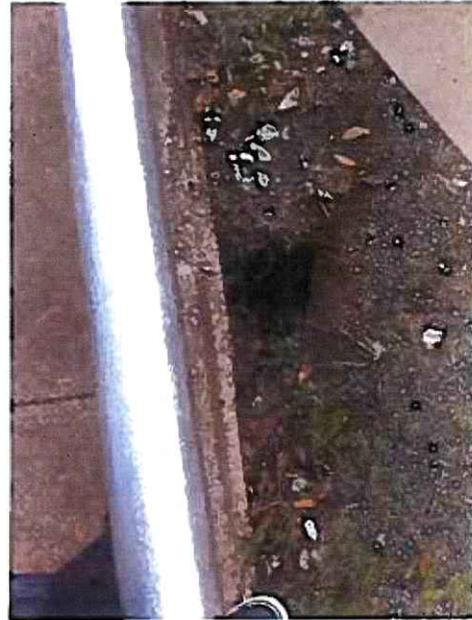
- I noted voids under the sidewalk where it has settled and cracked.

- Based on my site review I believe the settlement of the soil and sidewalk is an erosion issue. I believe water is getting in behind the upstream wing walls during high water events and traveling behind the bridge wall and weeping through the weep holes on the downstream wing walls. Water is getting behind the upstream wing walls through the cracks and damage at the intersection of the wing wall and bridge, see the attached pictures. I anticipate that soil has been eroded even under the road at the intersection of the road and the bridge, but the structural capabilities of the road have limited the amount of cracking here. However, some cracking of the road is occurring at this location as well.

Picture 11 – A picture of one of the areas where soil has eroded under the sidewalk.

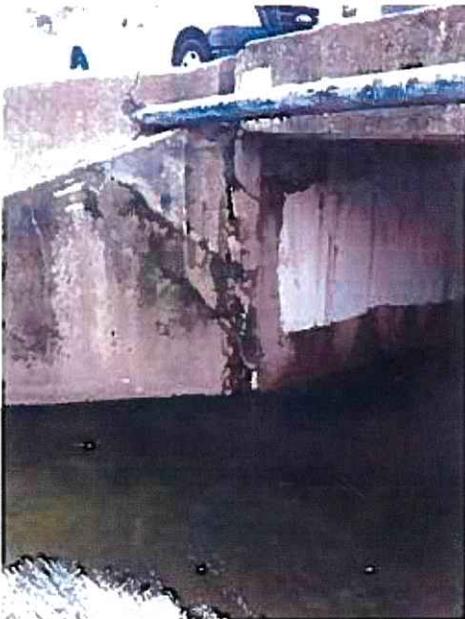
Picture 10 – Another picture of the upstream wing wall on the south at the connection to the bridge.

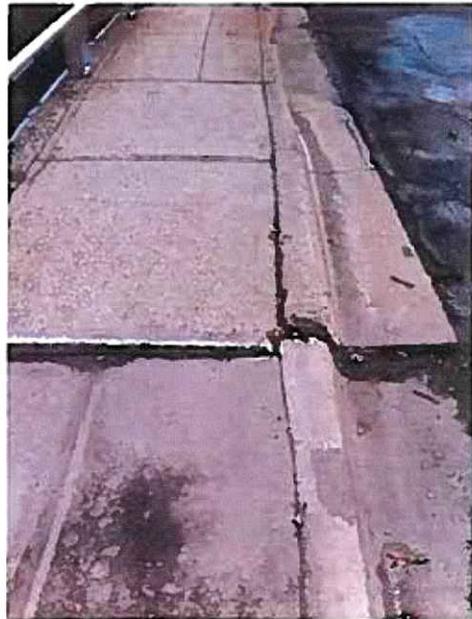
- I did not note any signs of overturning of the wing walls.
- I noted the sidewalk had settled fairly significantly where it adjoins the bridge, especially on the north side.

Picture 12 – A picture of the sidewalk showing the settlement.

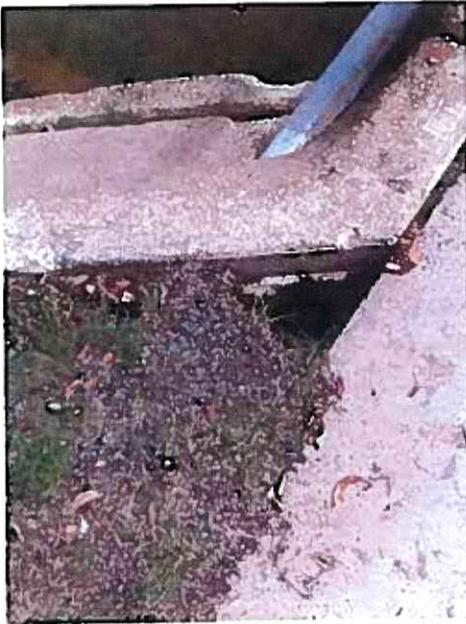
Picture 13 – Another picture of one of the areas where soil has eroded under the sidewalk.

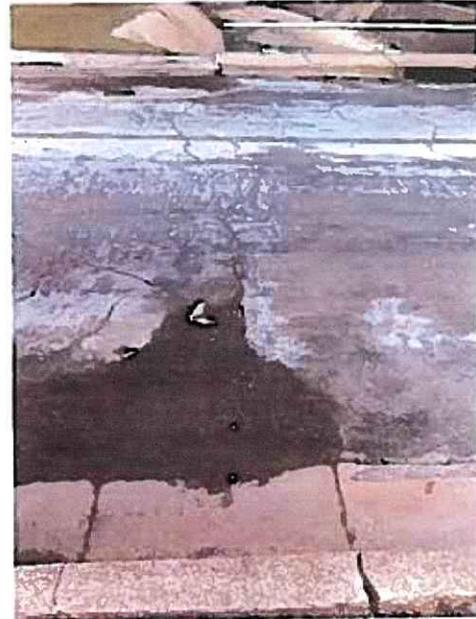
Picture 15 – Another picture of the drive along where soil is eroding. Note the crack in the pavement along this intersection.

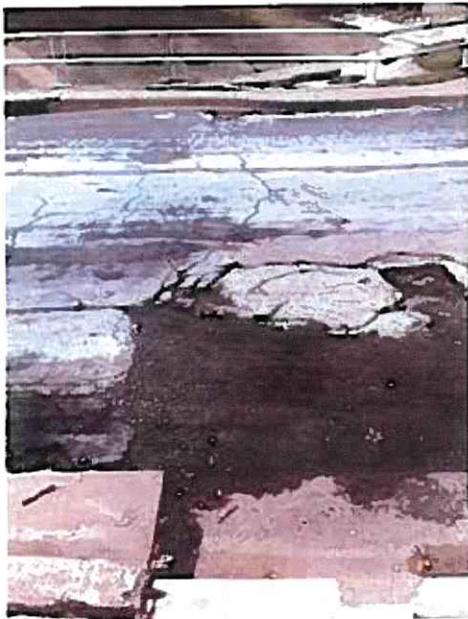
Picture 14 – A picture of the drive along where soil is eroding. Note the crack in the pavement along this intersection.
