# EXHIBIT "A"

Re: Structural Review of Bridge and Abutment Walls at Wagonwheel  
Wagonwheel Bridge  
Wagonwheel Trail Bridge between La Costa Ct. and Country Club Rd.  
Pantego, Texas  
Falkofske Engineering Job No. 170.14  
Texas Registered Engineering Firm #F-4038

**Pictures from Field Review 4-17-14**

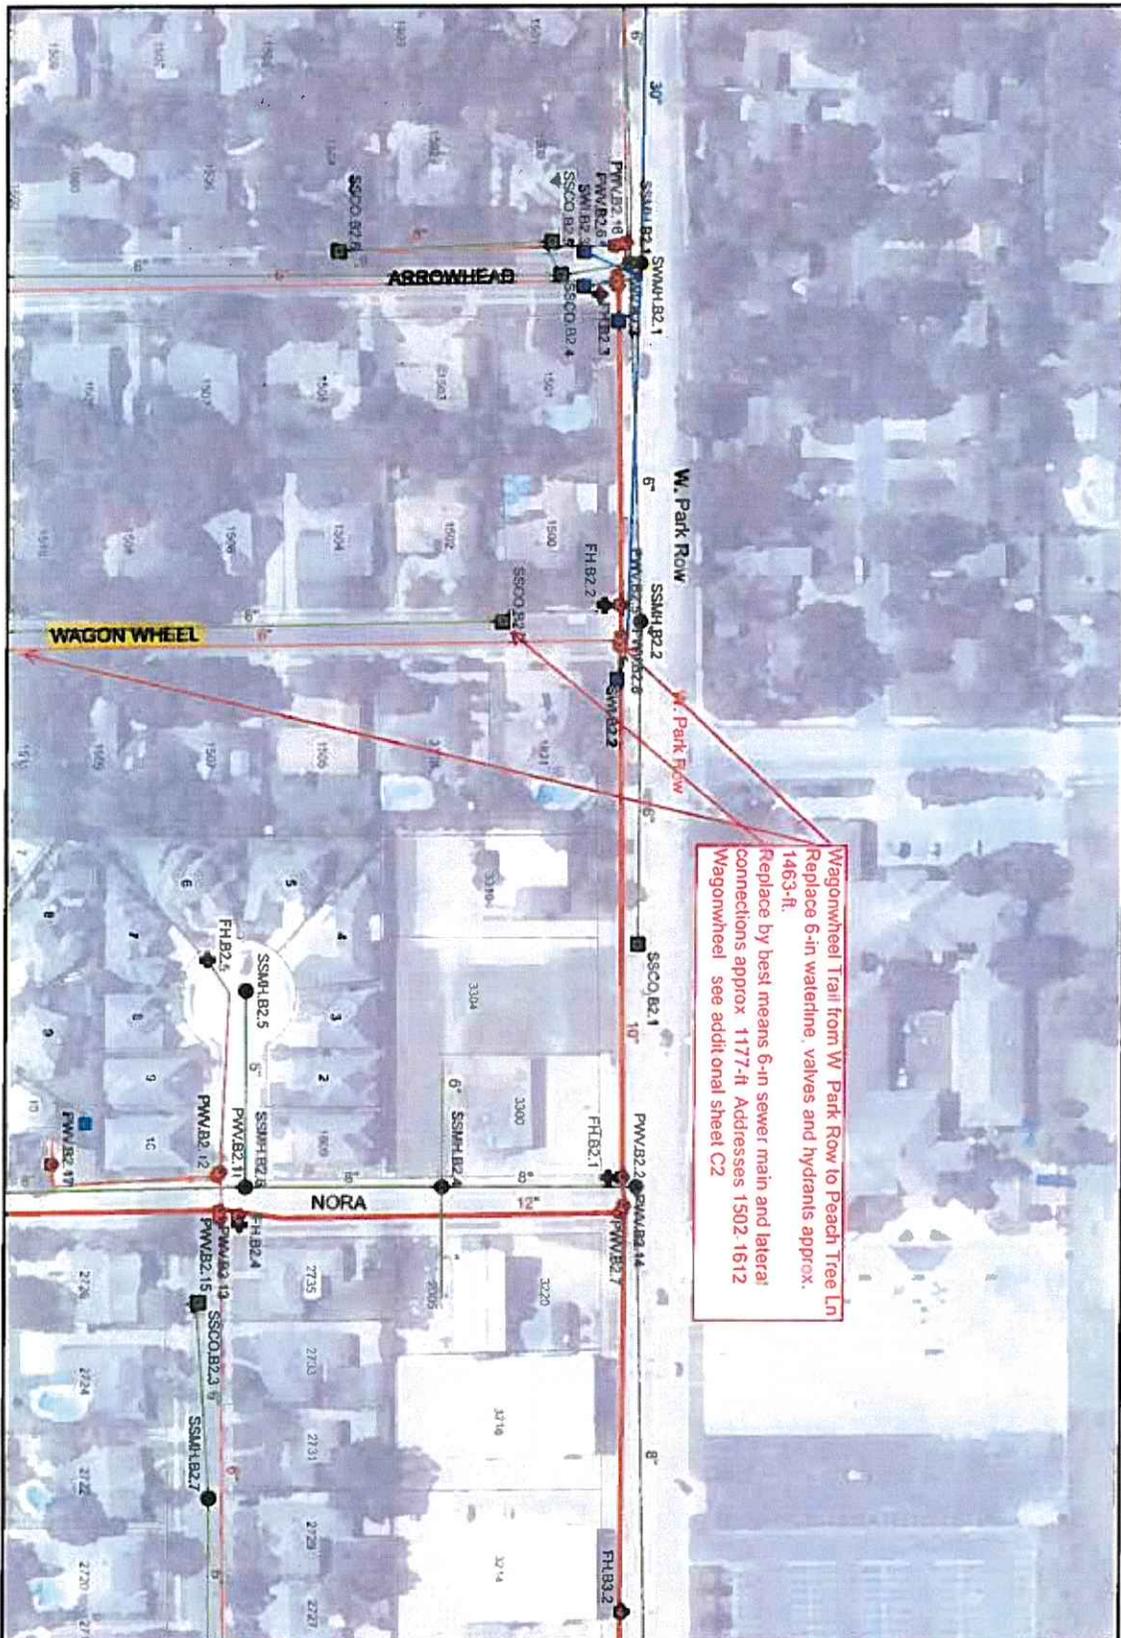
**B2**

Wagonwheel Trail from W Park Row to Peach Tree Ln  
 Replace 6-in waterline, valves and hydrants approx. 1463-ft.  
 Replace by best means 6-in sewer main and lateral connections approx. 1177-ft. Addresses 1502-1612  
 Wagonwheel see additional sheet C2

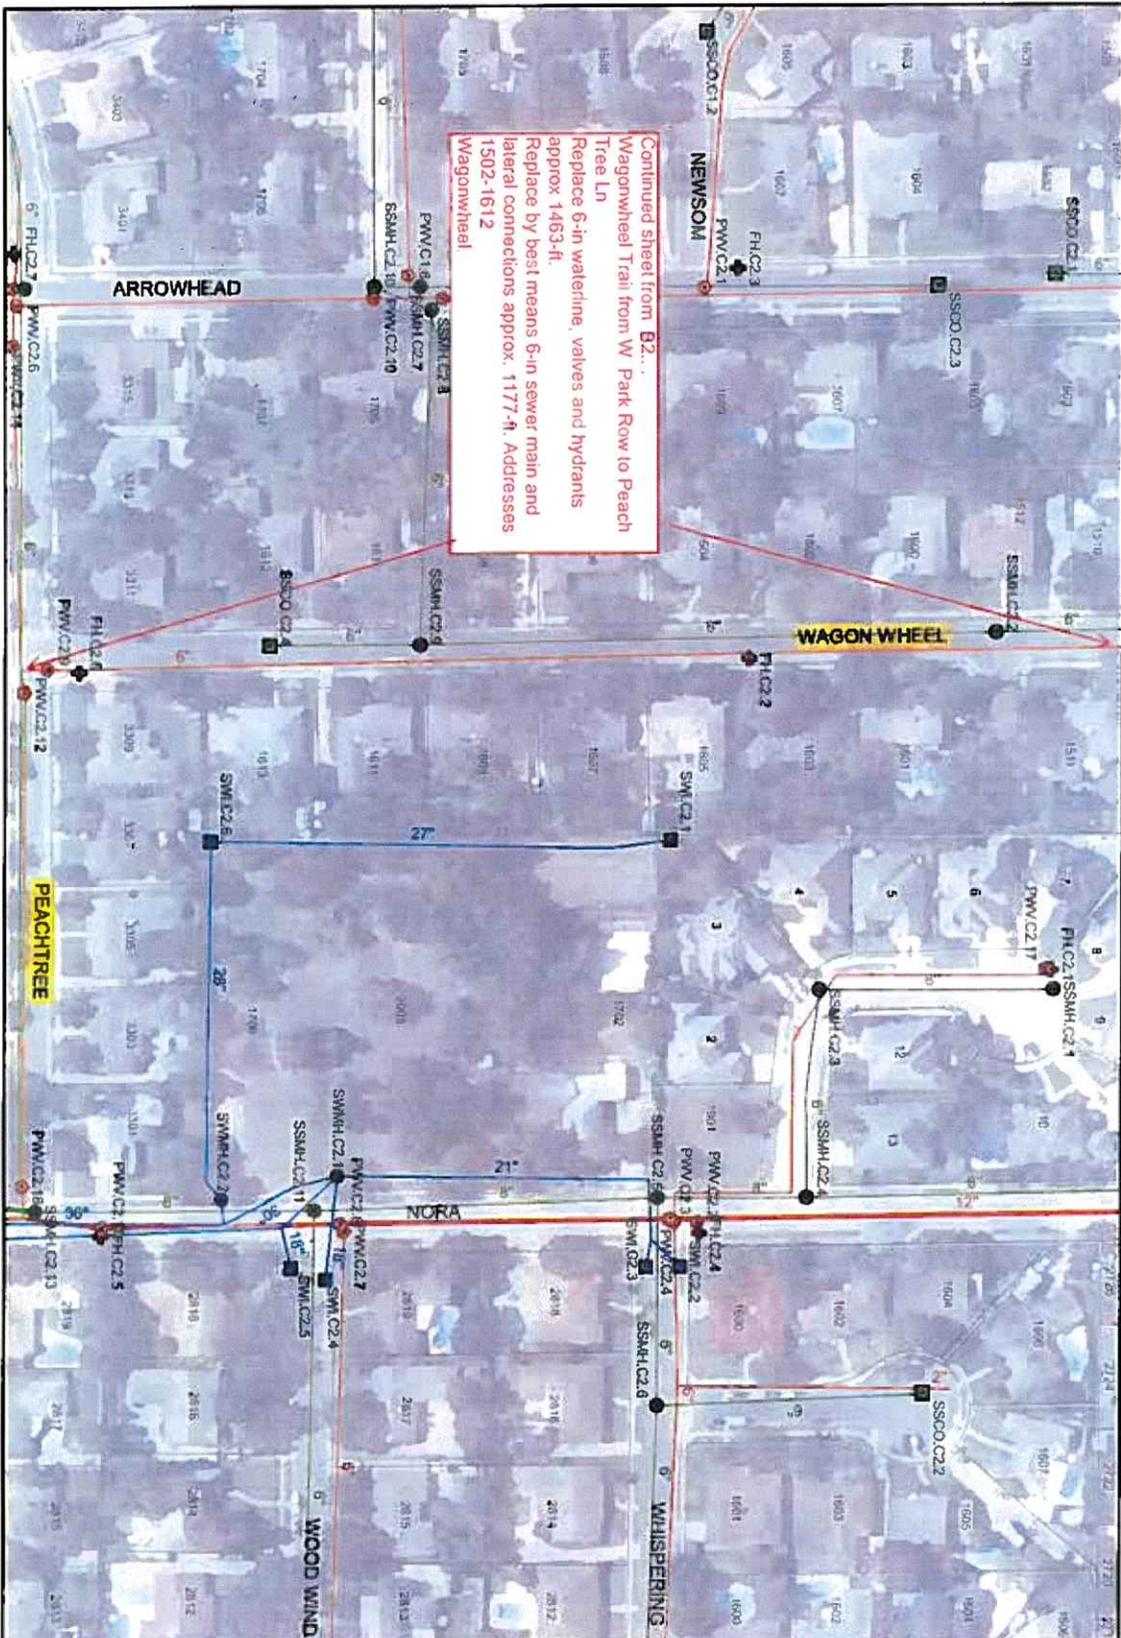
Continued sheet from B2...  
 Replace 6-in waterline, valves and hydrants  
 approx. 1463-ft.  
 Replace by best means 6-in sewer main and  
 lateral connections approx. 1177-ft. Addresses  
 1502-1612  
 Wagonwheel
